**Supplementary Material**

Table 1: Satellite figures and description of land use and occupation around the sampled points.

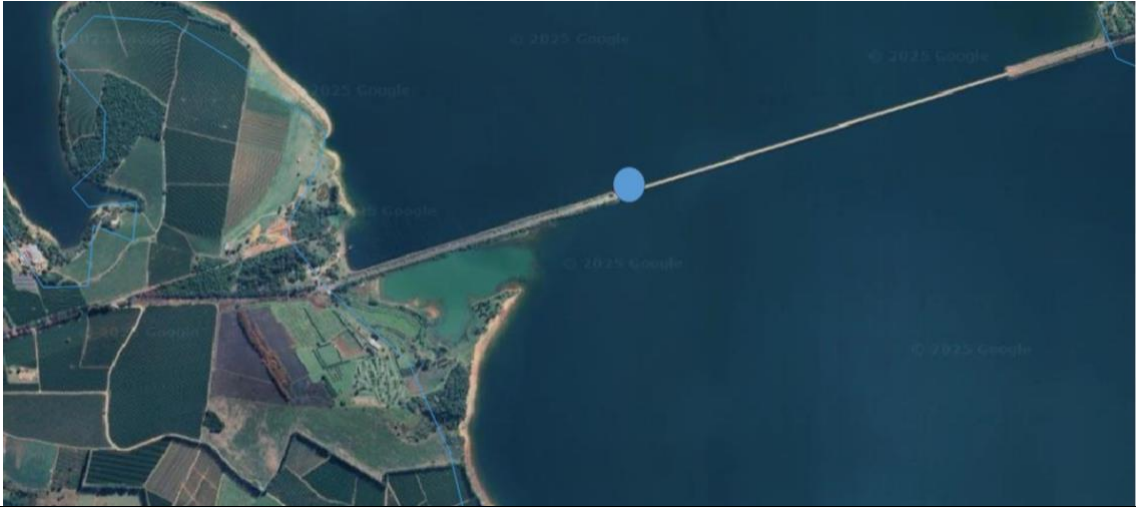
Sampling point	Description of land use and land cover surrounding the sampled site.
R1	<p>The sampling area at this site is located in a branch of the reservoir. The surrounding landscape consists of a matrix of pastures and dense secondary vegetation. There is no evidence of large-scale monocultures or high-intensity agricultural intervention in the immediate vicinity of the sampling location.</p>

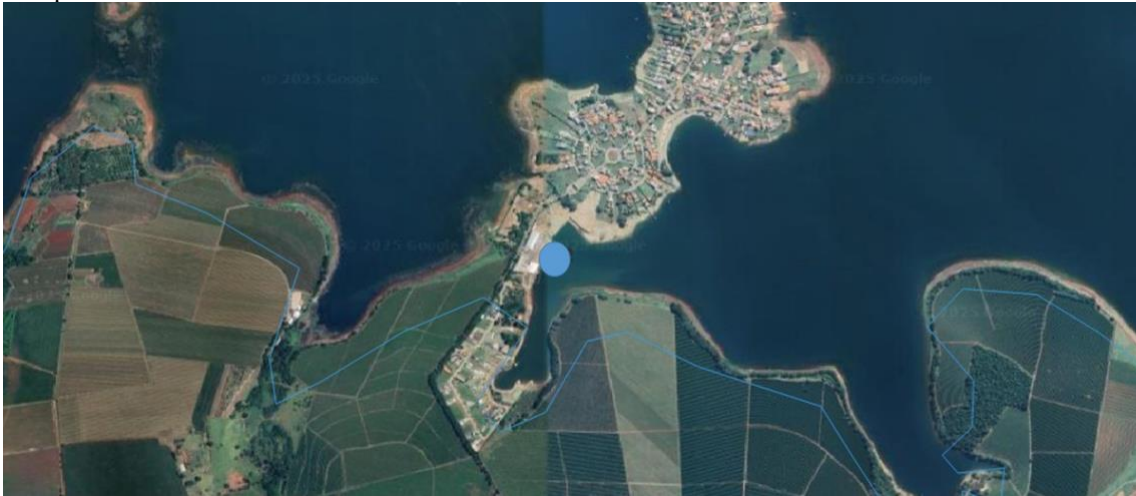
R2	<p>This point is located within the reservoir. The land use and land cover along the margins are of a mixed nature, including pastures, some areas of secondary vegetation, and a large cluster of anthropogenic land occupation.</p>

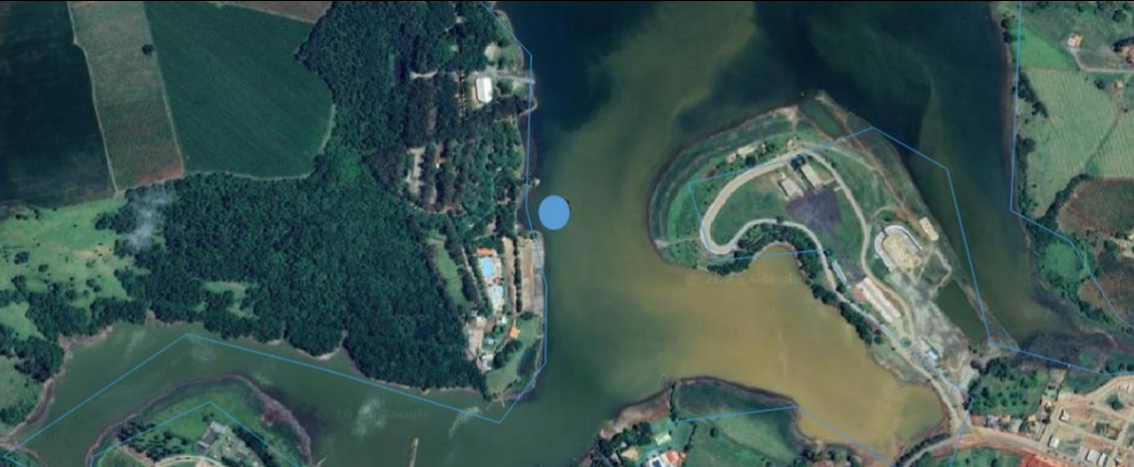
R3	<p>The sampling site is located in a narrower portion of the reservoir. The landscape is characterized by dense native vegetation or secondary forest cover, suggesting a more preserved environment. Some pasture areas and small-scale agriculture are visible in more distant portions of the sampling site.</p>

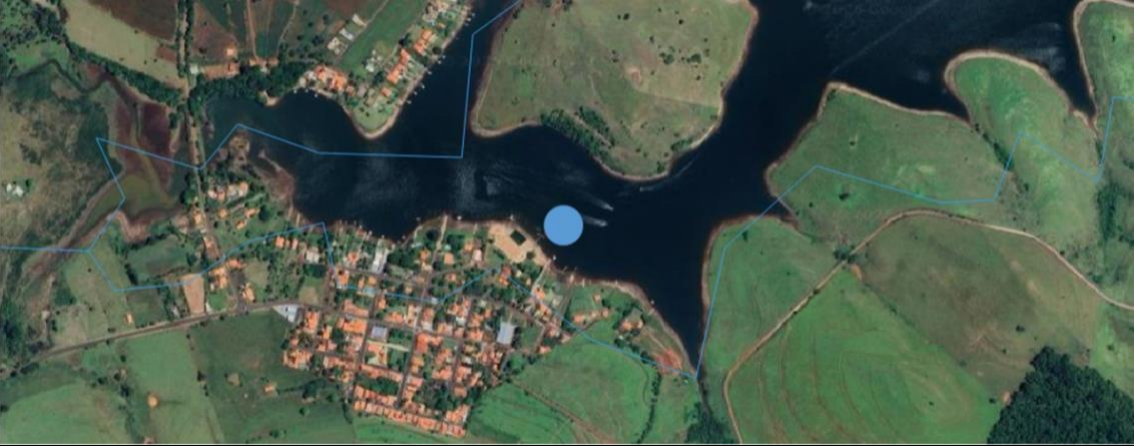
<p>R4</p>	<p>This point is located in a more open area of the reservoir. The surrounding landscape is predominantly composed of pastures, with visible areas of residential or recreational development along the shoreline. There are few patches of native vegetation, indicating that the land-use matrix is dominated by direct land-use activities and residential occupation.</p>

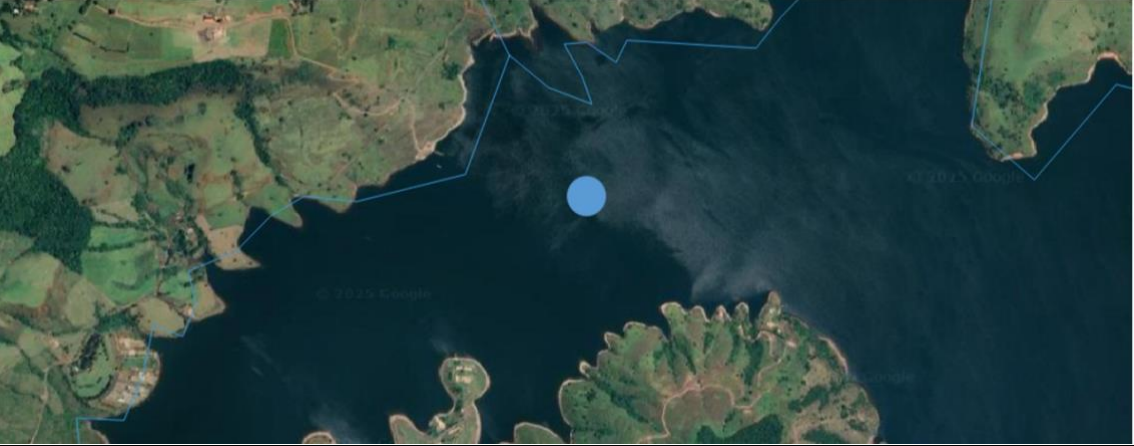
<p>R5</p>	<p>The sampling was conducted in the reservoir. The surrounding environment is characterized by extensive large-scale pasture areas, with clearly defined fields extending to the immediate vicinity of the reservoir bed. The riparian vegetation strip is extremely narrow or absent, indicating strong pressure from agricultural activity on the watercourse.</p>

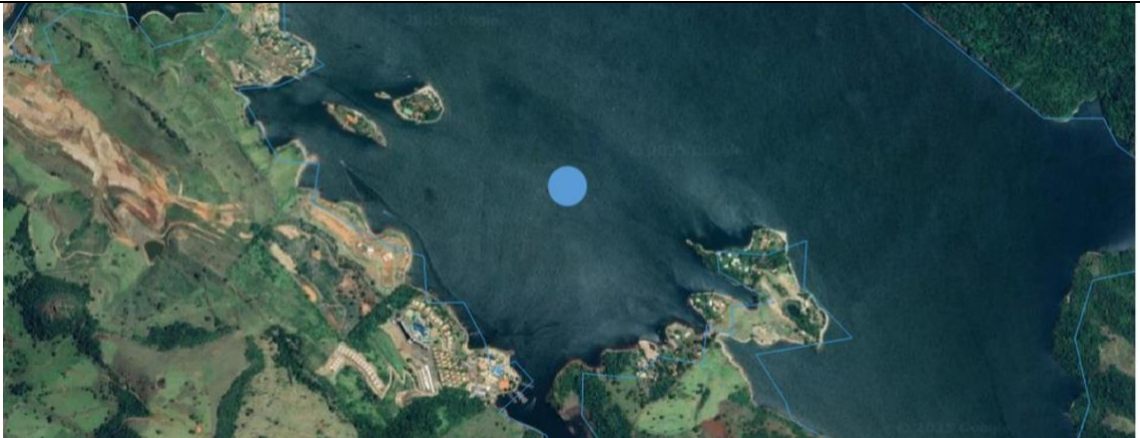
<p>R6</p>	<p>This point is located within the reservoir. The landscape remains dominated by large agricultural fields, with a narrow strip of riparian vegetation. The uniformity of the agricultural landscape suggests a significant contribution of inputs and potential surface runoff into the reservoir.</p>

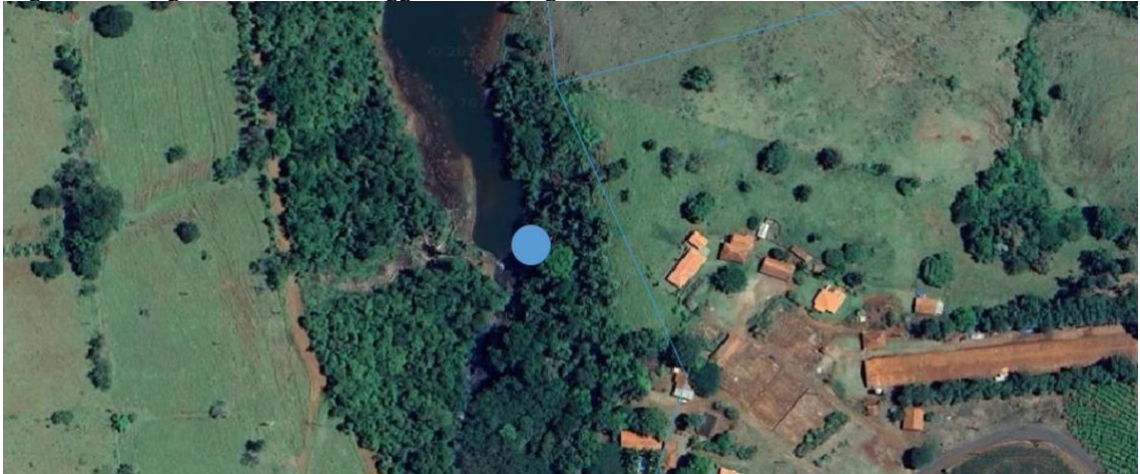
R7	<p>The sampling site is located at the end of a smaller branch of the reservoir. Land use and land cover form a mosaic of pastures, agricultural areas, and patches of secondary vegetation. The fragmentation of vegetation along the watercourse suggests a drainage basin with considerable human intervention.</p>

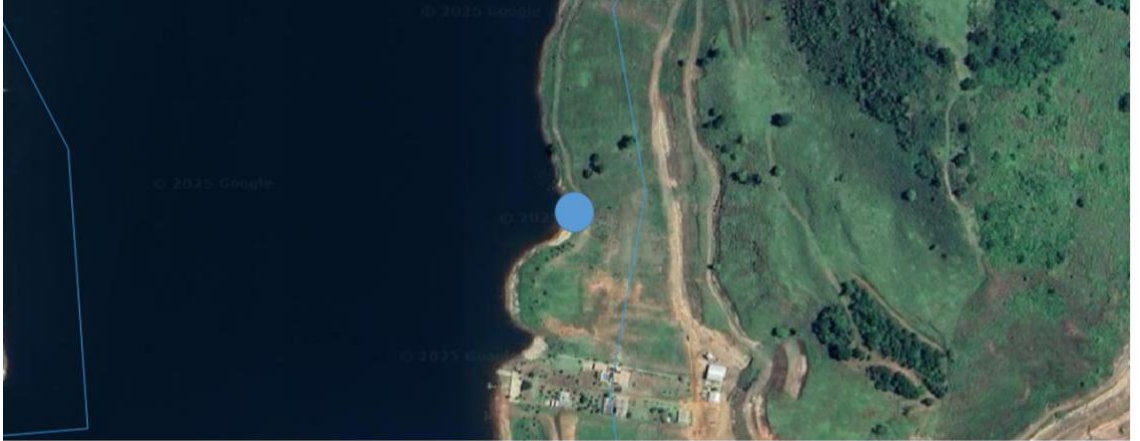
R8	<p>This point is located in the reservoir within a mixed landscape environment. The surrounding area is composed of pastures and some patches of forest. Riparian vegetation is not continuous, and the presence of a nearby road indicates easy access and potential impacts from road-related activities.</p>

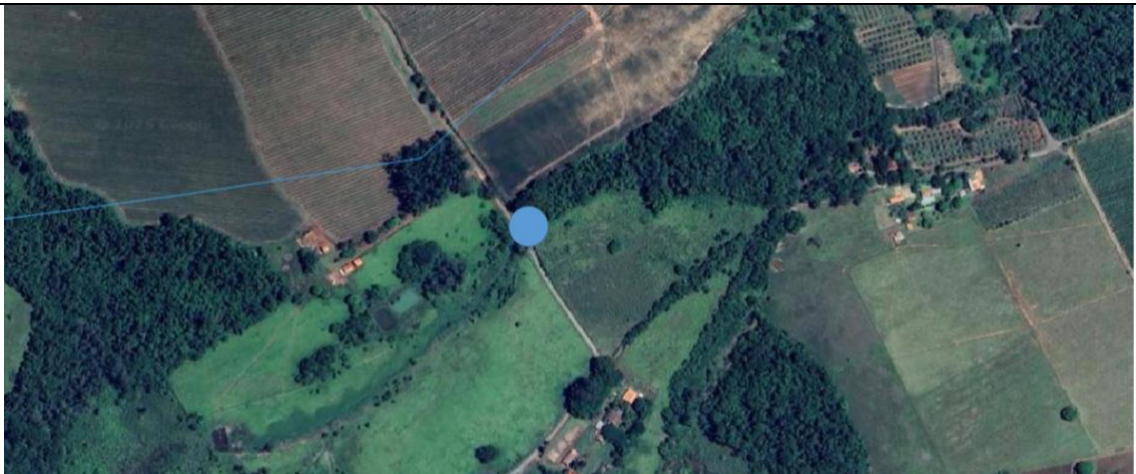
T1	<p>This point is located in an upstream tributary. The surrounding landscape is a heterogeneous mosaic of native or secondary vegetation, pastures, and agricultural areas. There are also signs of residential or recreational development along the margins, reflecting the multiple uses of the basin area.</p>

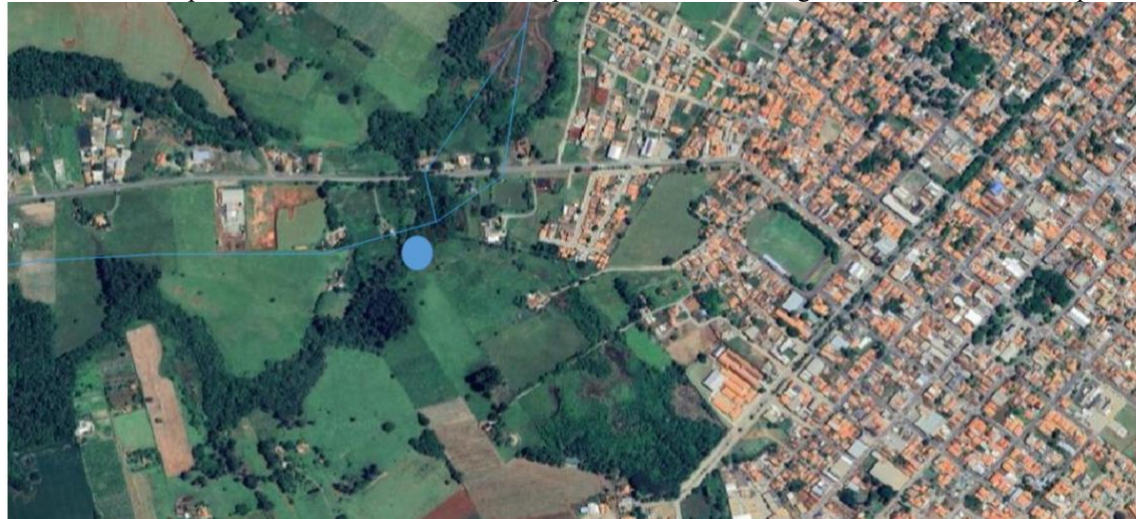
T2

The sampling site is located in an upstream tributary. The surrounding area is composed of pastures and agricultural land. The onset of the rural zone is evident, with boundaries clearly defined by human constructions. Although some riparian vegetation is present, its limited extent indicates that the watercourse is exposed to potential agricultural impacts.

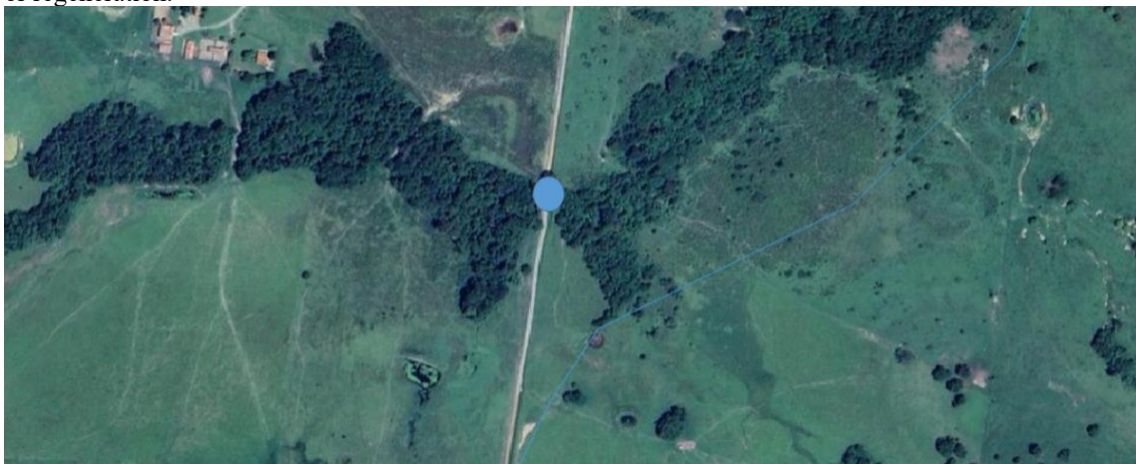
T3

The sampling area is located in an upstream tributary. The surrounding landscape features large pasture fields and portions of native vegetation or secondary forest. Land use and land cover around this site reflect the heterogeneous nature of the basin, with the presence of both agricultural activities and areas of preservation or regeneration.

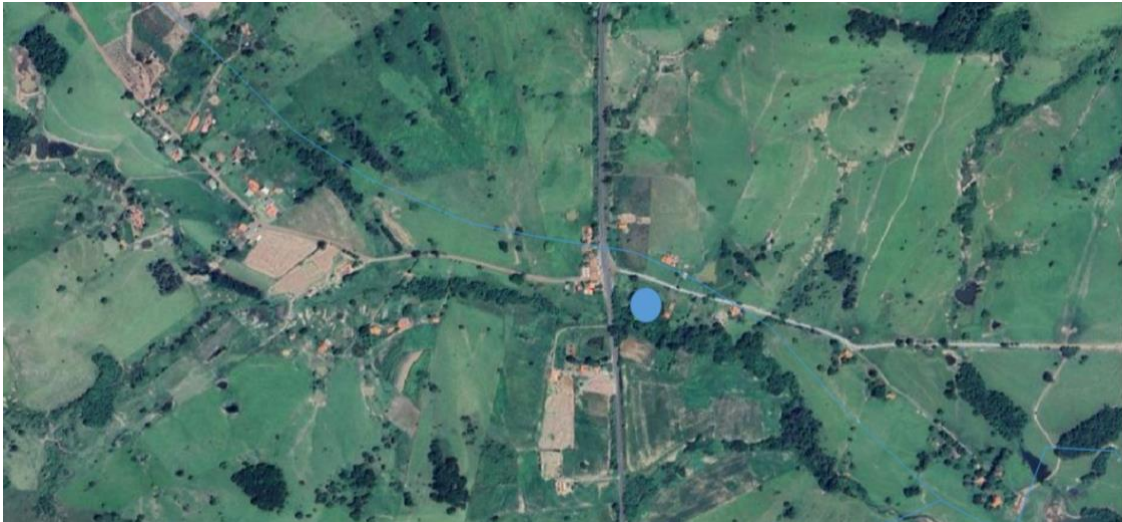
T4	<p>The sampling area is located in an upstream tributary. The surrounding landscape is a mosaic of different land uses, including a highway and local roads, pastures, agricultural areas, and patches of secondary vegetation. There are also signs of small-scale residential development along the margins, reflecting the multifunctional nature of land use.</p>

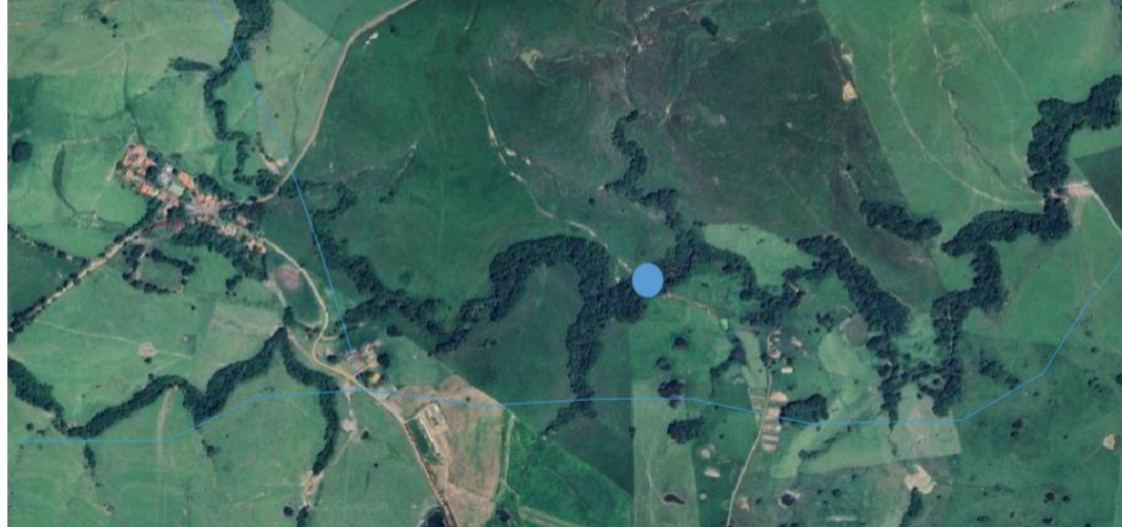
T5	<p>The sampling site is situated in an upstream tributary. The areas adjacent to the collection point are predominantly used for agricultural crops, interspersed with fragments of secondary or native vegetation. The presence of a well-defined agricultural matrix in the vicinity and the discontinuous riparian vegetation indicate significant anthropogenic pressure on the aquatic ecosystem.</p>

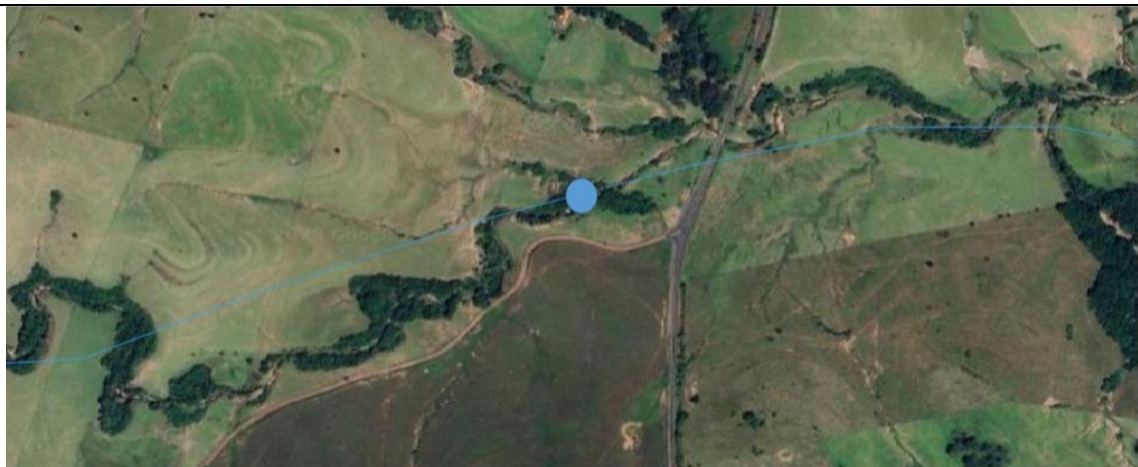
T6	<p>This point is located in an upstream tributary within a mixed landscape environment. The surrounding area is composed of pastures, agricultural fields, and some forest patches. Riparian vegetation is not continuous, and the presence of a nearby road indicates easy access and potential impacts from road-related activities.</p>

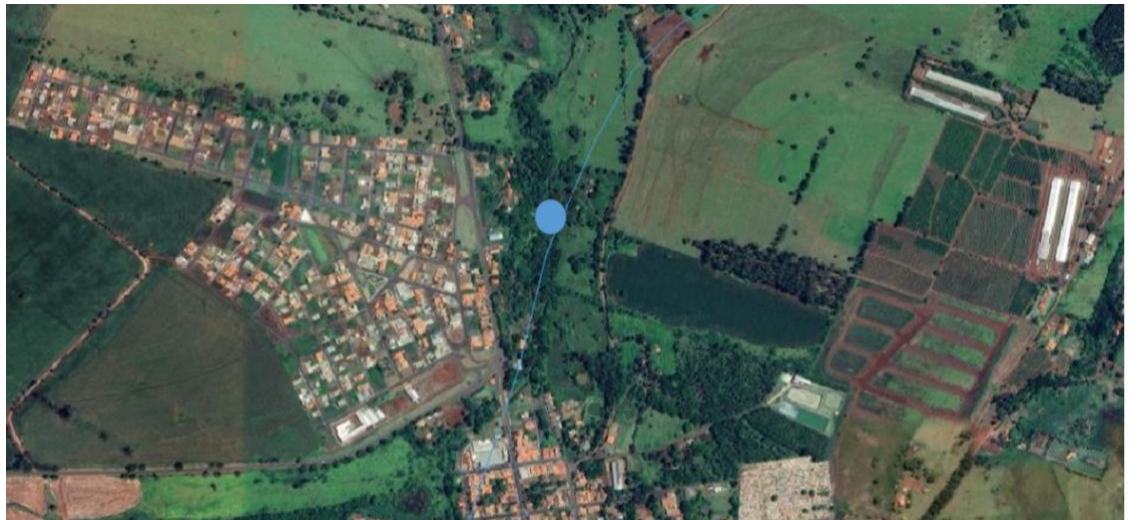
<p>T7</p>	<p>The sampling point is located in a tributary of Paranapanema River. The surrounding landscape is characterized by a land-use matrix dominated by agricultural areas and pastures extending to the shoreline. Signs of residential development are also visible near the site, with the presence of buildings and road access. The absence of continuous riparian vegetation indicates intense direct anthropogenic pressure on the aquatic ecosystem.</p>

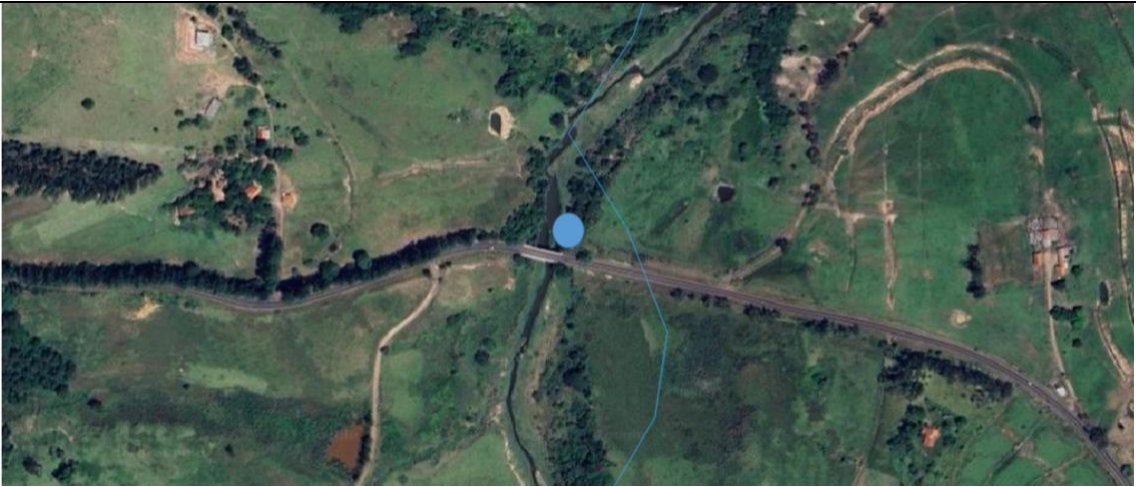
<p>T8</p>	<p>The sampling site is located in a tributary of Paranapanema River. The surrounding area is characterized by the absence of continuous riparian vegetation, which exposes the water body to intense anthropogenic pressure. Land use in the vicinity of the collection point is dominated by pastures and agricultural areas, with a highway visible running perpendicular to the river. The lack of riparian buffer indicates a high potential for surface runoff of sediments and pollutants into the aquatic ecosystem.</p>

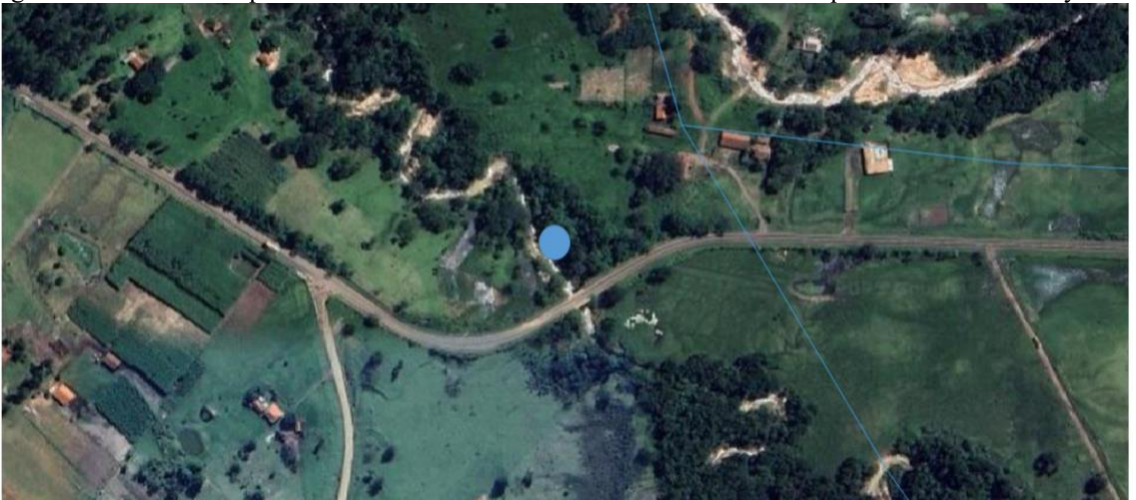
<p>T9</p>	<p>The sampling point is located in a tributary of Paranapanema River, where the surrounding landscape is characterized by a paved road crossing the water body via a bridge. Riparian vegetation is scarce, and land use in the vicinity is dominated by pastures, agricultural areas, and some residences. The proximity to the road and the lack of riparian forest indicate a high potential for surface runoff of road-related and agricultural pollutants into the aquatic ecosystem.</p>

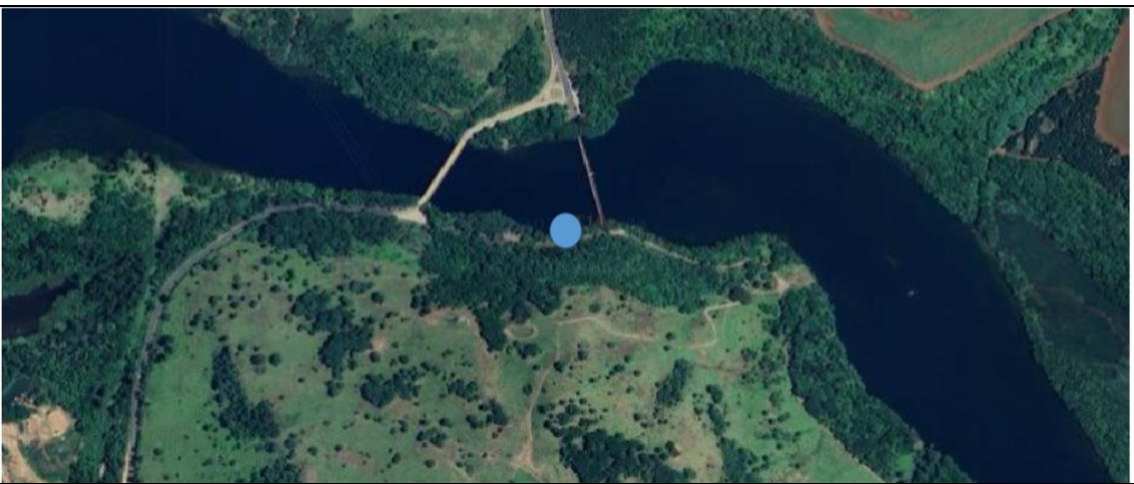
<p>T10</p>	<p>The sampling point is located in a wider water body, the Paranapanema River. Unlike other areas, the surrounding landscape is notable for the presence of a broader riparian forest extending along the riverbanks. Although the area beyond the riparian vegetation is characterized by pastures and agriculture, the presence of a more robust protective strip suggests a potential attenuation of surface runoff from rural activities, providing greater protection to the aquatic ecosystem.</p>

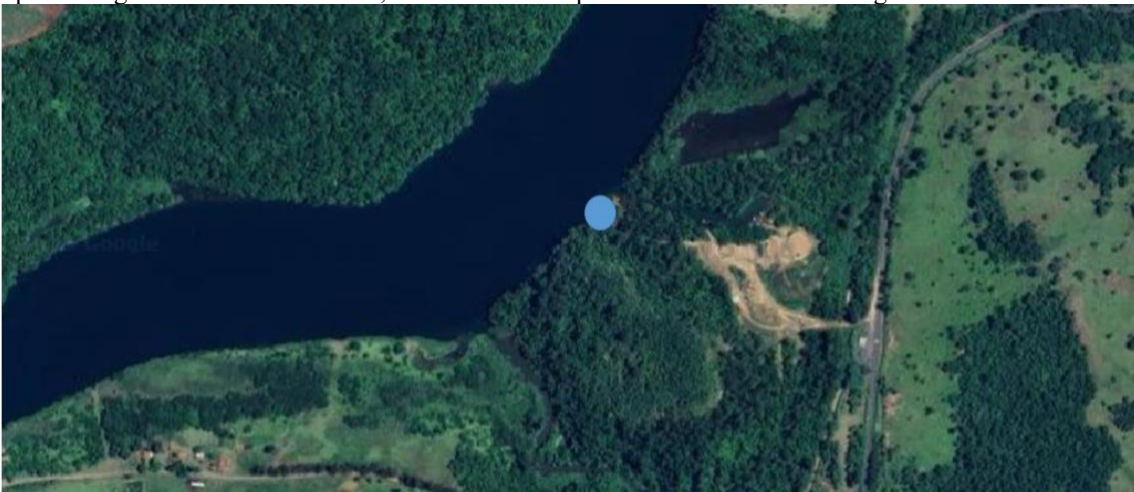
T11	<p>The sampling point is located on the banks of the Paranapanema River. On one riverbank, a wide and well-preserved riparian forest is observed, indicating a robust vegetative protection area. On the opposite bank, riparian vegetation is discontinuous, with stretches of pasture and a visible clearing.</p>
